INFRARED THERMOGRAPHIC SURVEY

Survey Performed
02 October, 2008

By
Sandy J. Sanor
Director
HSB Thermography Services
Sandy_Sanor@hsb.com
703-739-0350

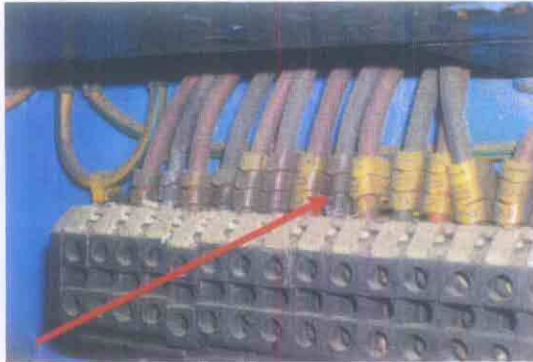
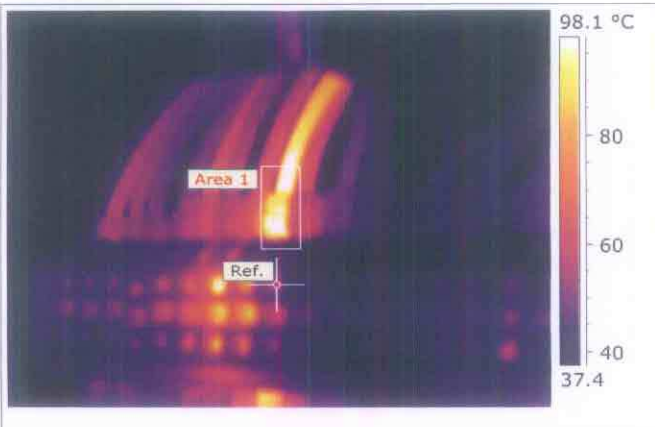
Location Area	Alimentatore
Equipment Location	46 Gruppo 4
Equipment ID	Lead to power strip
Est. Repair Cost Before Failure	€ 25
Est. Repair Cost After Failure	€ 50
Est. % of Production	0 %
Est. Down Time	0

Ref. Temperature	54.3 °C
Area 1 Max. Temperature	106.7 °C

Area 1: Temp. Rise 52.4 °C

The 8th lead from the left is very hot.

The connections should be disassembled, cleaned, the lead should be cut back to good metal and the power strip repaired as necessary. Reassemble and properly torque fasteners.

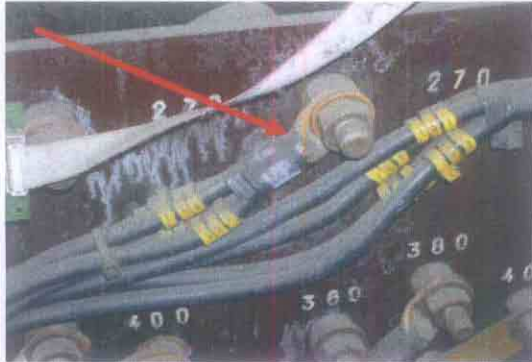
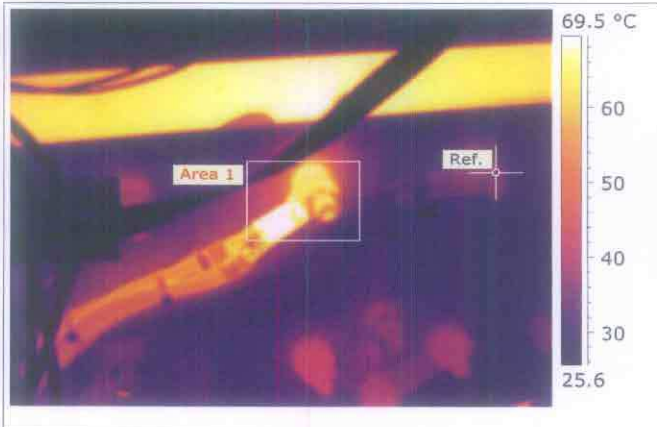
Location Area	Alimentatore
Equipment Location	47 Gruppo 3
Equipment ID	Connection to phase
Est. Repair Cost Before Failure	€ 50
Est. Repair Cost After Failure	€ 100
Est. % of Production	0 %
Est. Down Time	0

Ref. Temperature	35.4 °C
Area 1 Max. Temperature	71.3 °C

Area 1: Temp. Rise 35.8 °C

The problem is in the leads to the lug fitting.

The connections should be disassembled, cleaned, inspected for damage and replace the lug connection as. Reassemble and properly torque fasteners.

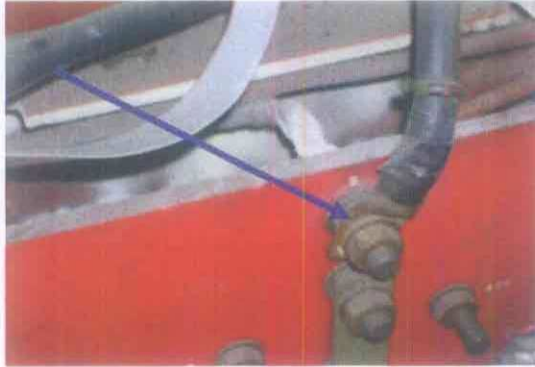
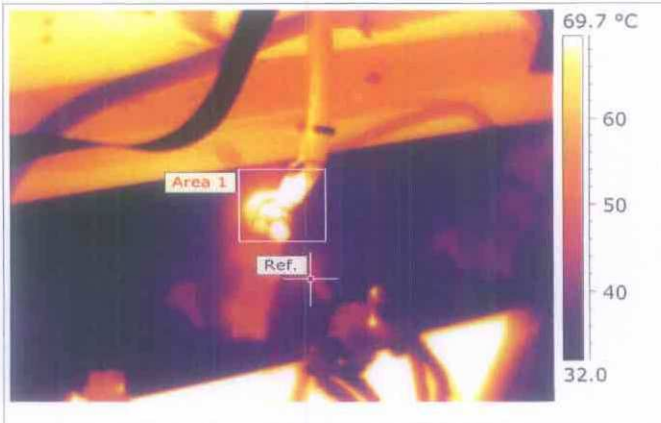
Location Area	Alimentatore
Equipment Location	10 Gruppo 3 & 4
Equipment ID	Middle phase
Est. Repair Cost Before Failure	€ 50
Est. Repair Cost After Failure	€ 100
Est. % of Production	0 %
Est. Down Time	0

Ref. Temperature	43.1 °C
Area 1 Max. Temperature	75.7 °C

Area 1: Temp. Rise	32.6 °C
--------------------	---------

The marked connection is very warm.

The connections should be disassembled, cleaned, inspected for damage and repaired as necessary. Reassemble and properly torque fasteners.

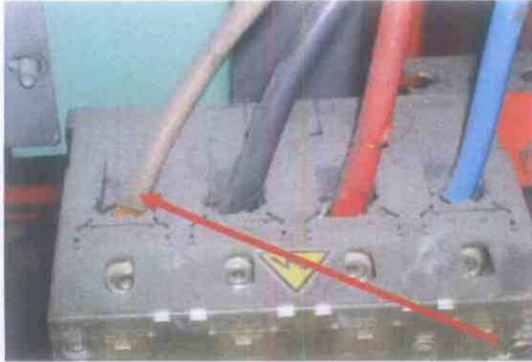
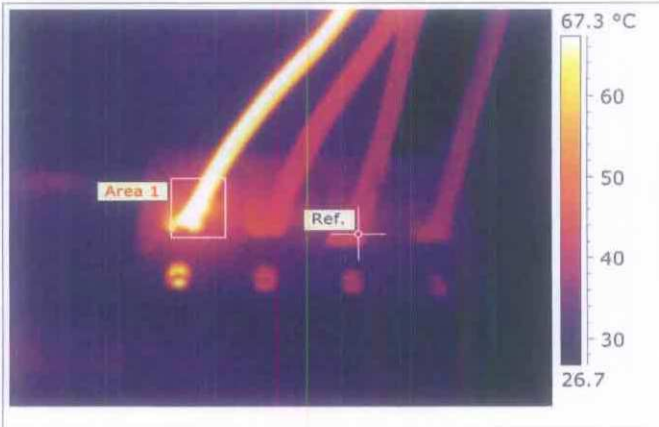
Location Area	Line #1
Equipment Location	Thermo Welding Machine Panel
Equipment ID	Main Disconnect
Est. Repair Cost Before Failure	€ 25
Est. Repair Cost After Failure	€ 200
Est. % of Production	0 %
Est. Down Time	0

Ref. Temperature	41.0 °C
Area 1 Max. Temperature	69.4 °C
Area 1: Temp. Rise	28.4 °C

The left phase is very warm.

The connections should be disassembled, cleaned, inspected for damage and repaired as necessary. Reassemble and properly torque fasteners.

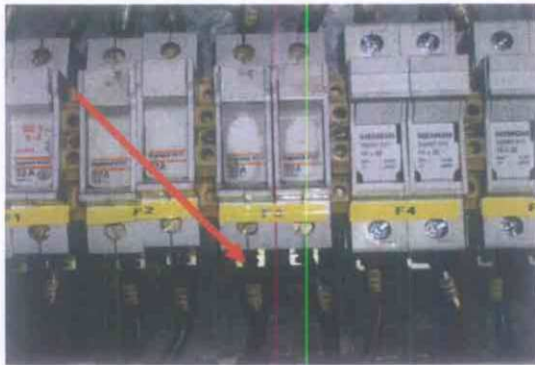
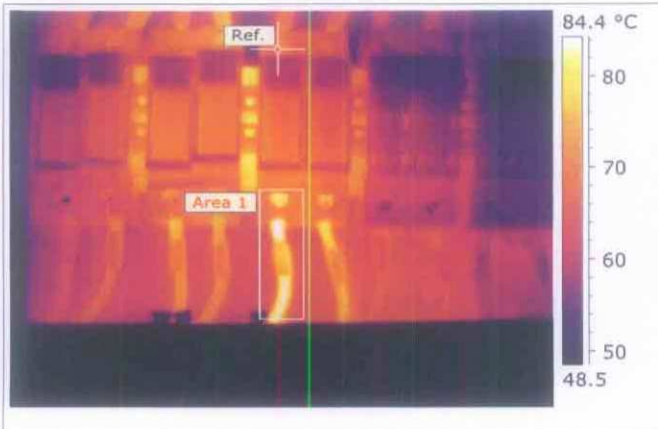
Location Area	Line #5
Equipment Location	C.O.S Panel
Equipment ID	Fuse #3 - resistenz dx
Est. Repair Cost Before Failure	€ 10
Est. Repair Cost After Failure	€ 75
Est. % of Production	0 %
Est. Down Time	0

Ref. Temperature	67.4 °C
Area 1 Max. Temperature	89.8 °C
Area 1: Temp. Rise	22.4 °C

The marked lead of the fuse is very warm

The connections should be disassembled, cleaned, inspected for damage, and the lead cut back to good metal. Reassemble and properly torque fasteners.

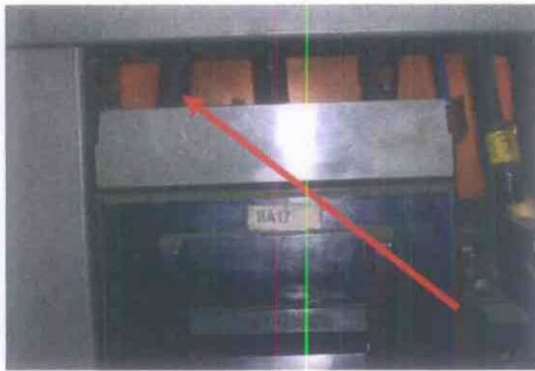
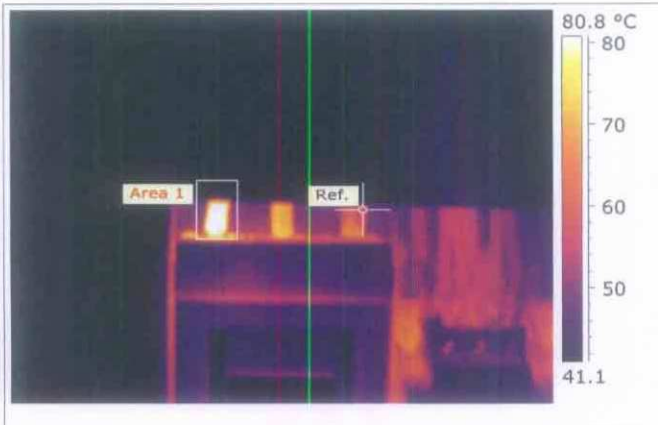
Location Area	Mulino #2
Equipment Location	Campo 9
Equipment ID	Circuit Breaker 11A17
Est. Repair Cost Before Failure	€ 50
Est. Repair Cost After Failure	€ 200
Est. % of Production	0 %
Est. Down Time	0

Ref. Temperature	58.1 °C
Area 1 Max. Temperature	93.5 °C
Area 1: Temp. Rise	35.4 °C

The left phase is elevated in temperature.

The connections should be disassembled, cleaned, inspected for damage and repaired as necessary. Reassemble and properly lubricate and torque fasteners according to the manufacturer's specifications, using new hardware as required.

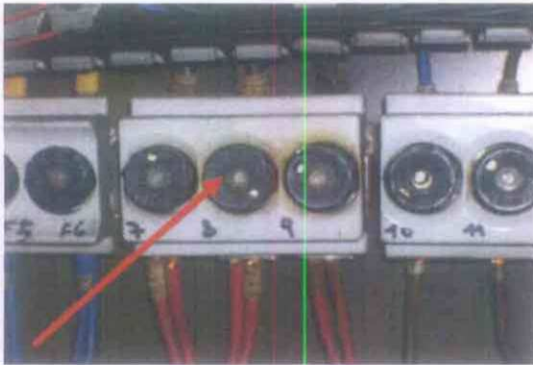
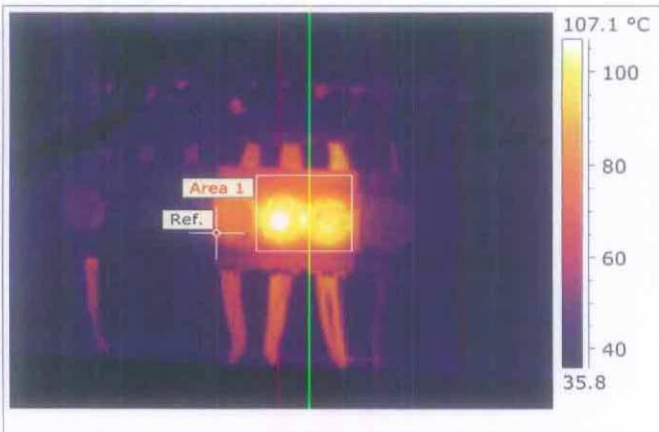
Location Area	FMWS #1
Equipment Location	GRAMEGNA Panel
Equipment ID	Fuse #8
Est. Repair Cost Before Failure	€ 10
Est. Repair Cost After Failure	€ 50
Est. % of Production	0 %
Est. Down Time	0

Ref. Temperature	61.8 °C
Area 1 Max. Temperature	110.9 °C
Area 1: Temp. Rise	49.1 °C

The #8 fuse is very hot. This is likely to be a problem with the fuse and fuse holder.

The fuse should be removed, cleaned, inspect the fuse holder for damage and repair as necessary. Reassemble and properly tighten.

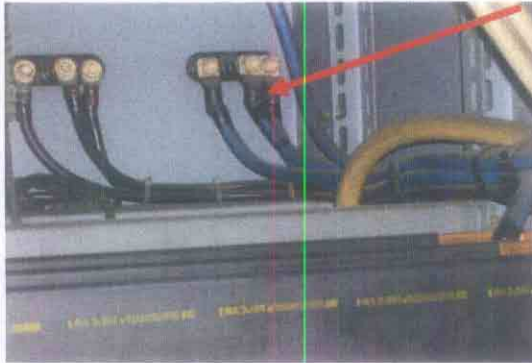
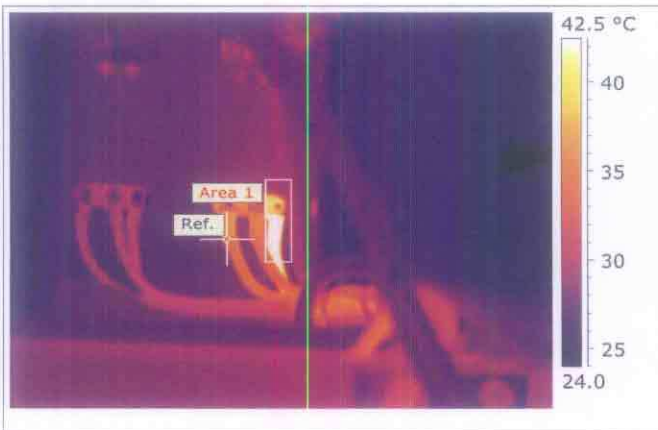
Location Area	Elettrica Cabina #1
Equipment Location	Acqua Vascone #37
Equipment ID	Circuit Breaker Phase
Est. Repair Cost Before Failure	€ 50
Est. Repair Cost After Failure	€ 200
Est. % of Production	0 %
Est. Down Time	0

Ref. Temperature	34.7 °C
Area 1 Max. Temperature	49.4 °C

Area 1: Temp. Rise	14.7 °C
--------------------	---------

The marked connection is elevated in temperature.

The connections should be disassembled, cleaned, inspected for damage and repaired as necessary. Reassemble and properly lubricate and torque fasteners according to the manufacturer's specifications, using new hardware as required.

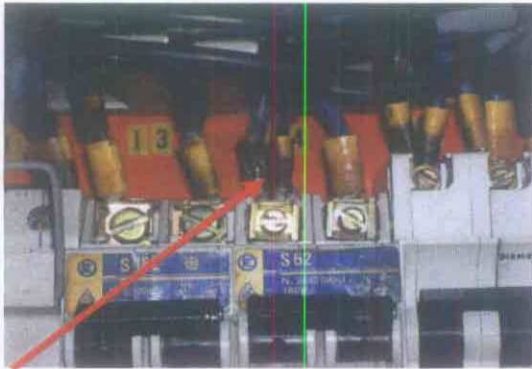
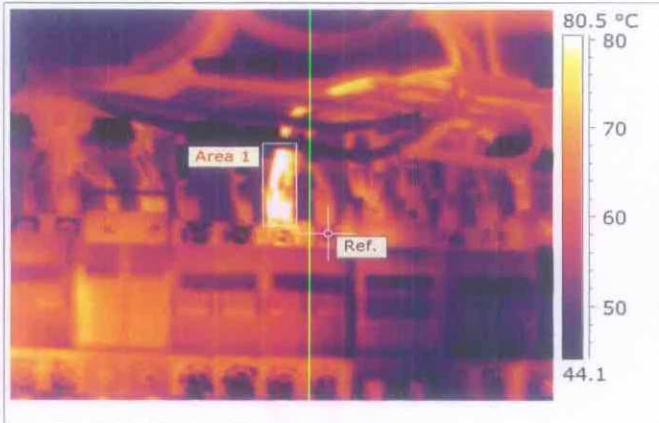
Location Area	Line 1,2 3,4 and 5
Equipment Location	Panel for the lighting
Equipment ID	Circuit Breaker 14
Est. Repair Cost Before Failure	€ 15
Est. Repair Cost After Failure	€ 50
Est. % of Production	0 %
Est. Down Time	0

Ref. Temperature	53.8 °C
Area 1 Max. Temperature	91.5 °C
Area 2 Max. Temperature	-
Area 3 Max. Temperature	-

Area 1: Temp. Rise	37.7 °C
Area 2: Temp. Rise	0.0 °C
Area 3: Temp. Rise	0.0 °C

The marked leads are very hot.

The connections should be disassembled, cleaned, inspected for damage and the leads cut back to good metal. Reassemble and properly torque fasteners.
