EQECAT preliminary report into the flooding of the Elbe and Donau, August 2002

Report by J Toothill, 22nd August 2002

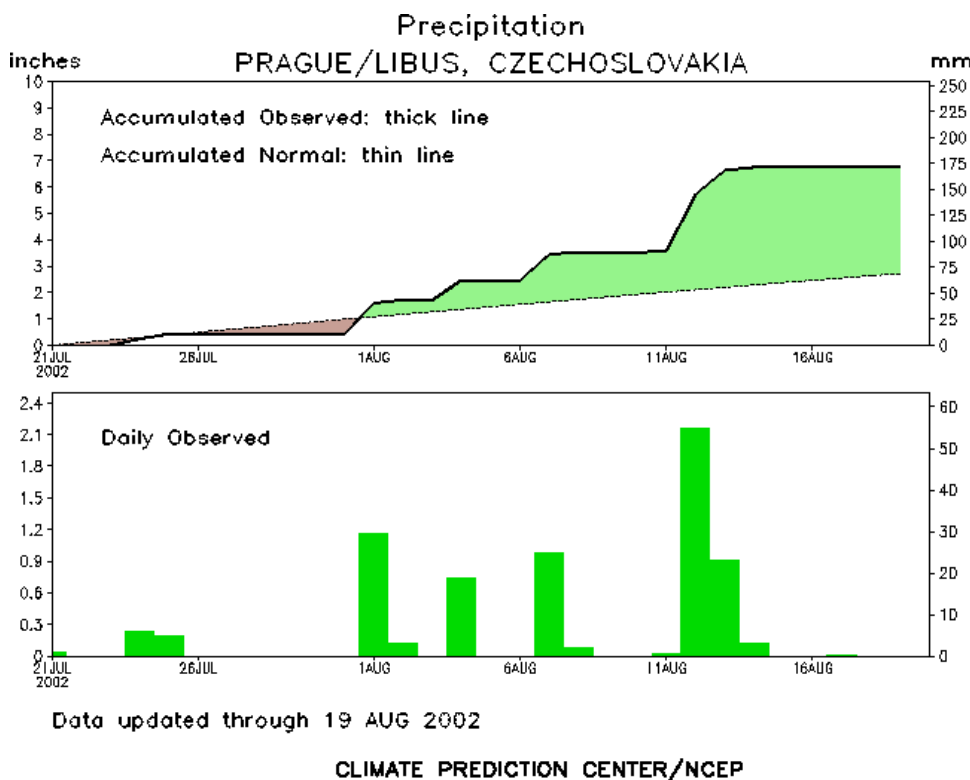
Comparisons between the normal and observed rainfall for this period for many locations in Central Europe reveal that rainfall in the first two weeks of August was two to three times the normal level for this time of year. The example for Prague (*left*) shows four periods of heavy rain, cumulating in two days of exceptional rainfall on the 12th and 13th of August. This pattern was repeated throughout the catchments of the Elbe and Danube rivers.

Daily observed rainfall and accumulated observed rainfall compared to normal in Prague for the period 21st to 17th August.

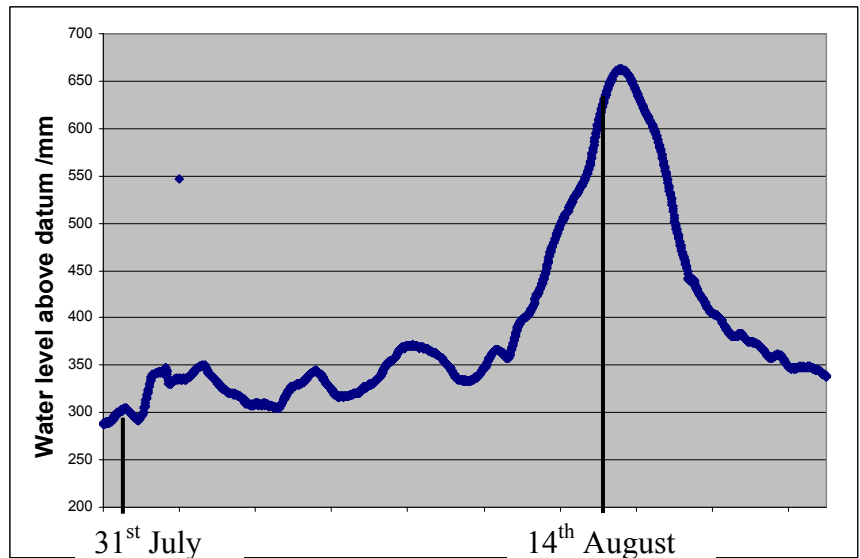
A flood hydrograph of the event is shown for Schwabelweis on the Danube. The flood is seen as a single distinct peak in the hydrograph.

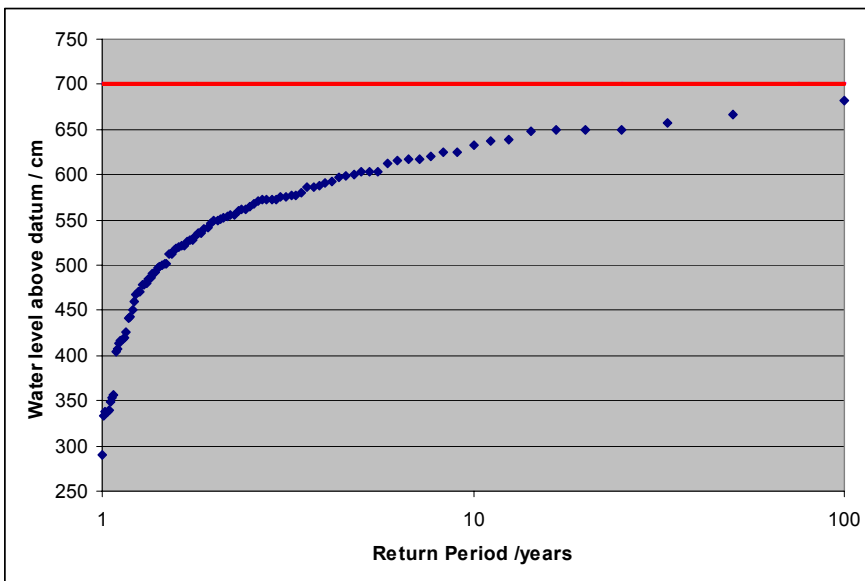
An example is given for Barby, near Dresden. The water level – return period relationship for annual maxima data recorded prior to 2002 is shown in blue and the level of the August 2002 flood is shown by the red horizontal line. The water level in the current event exceeds any previously recorded data.

Water level – frequency relationship at Barby, near Dresden. Annual maxima data for the 100-year period 1900 – 2000 are shown. The level of the August 2002 flood is indicated by the red horizontal line.

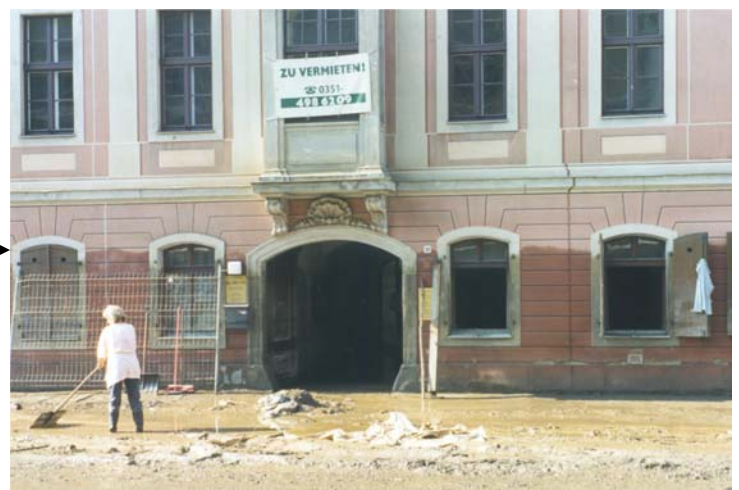
Clean-up operations in Dresden. The water level in this street, located over 0.5km from the Elbe, reached 2m above street level. The high water mark can clearly be seen on the wall of the building.

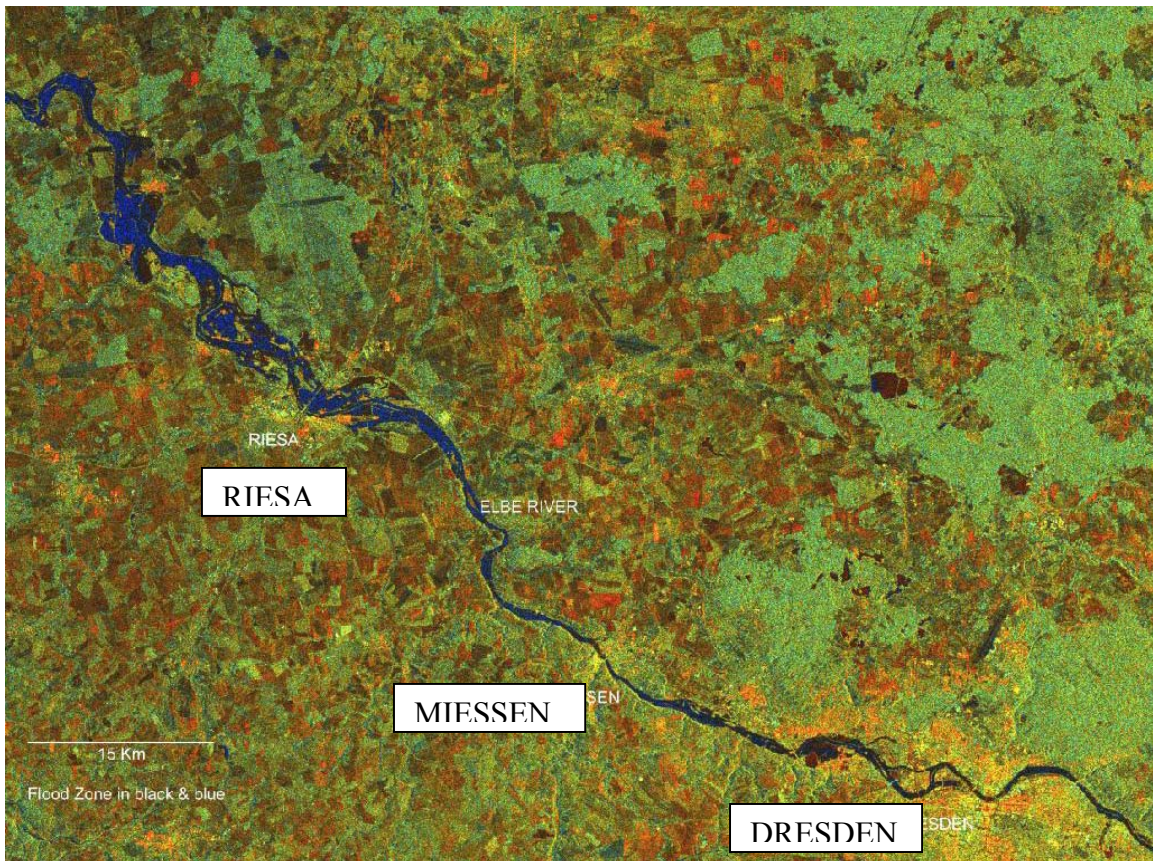
A satellite picture of Sachsen, Germany shows the extent of flooding on the Elbe downstream from Dresden. *Source: Earthnet Online (ESA)*

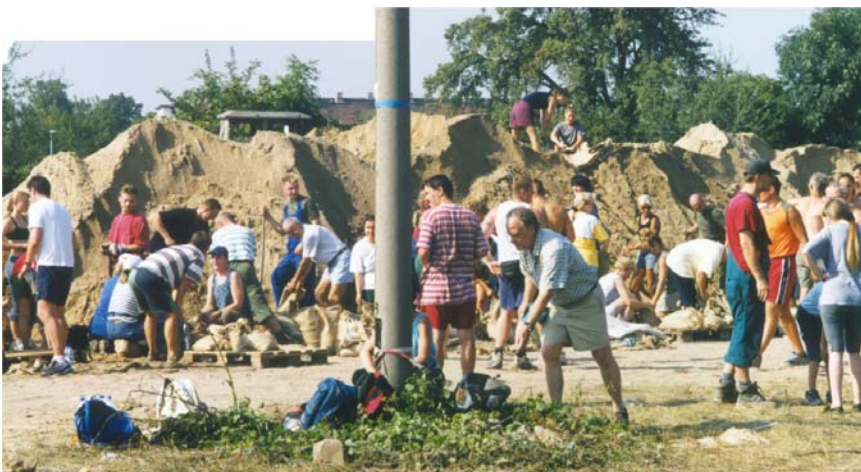
Preparation of sand bags in Magdeburg

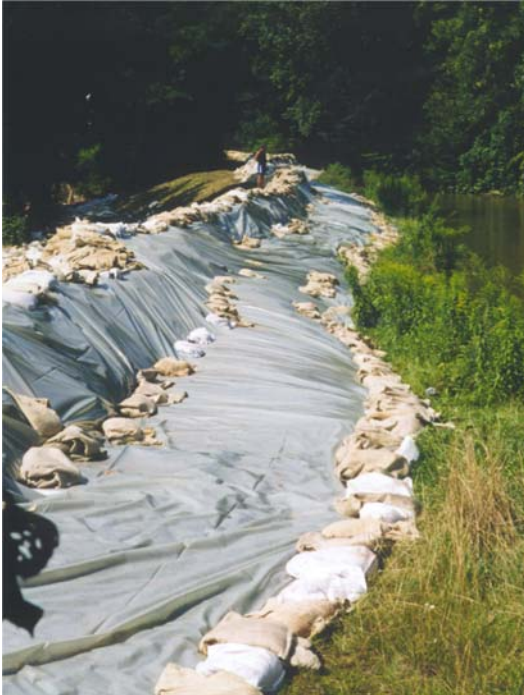
Waiting for the flood: Sandbag and wooden board protection of property in an evacuated area of Magdeburg

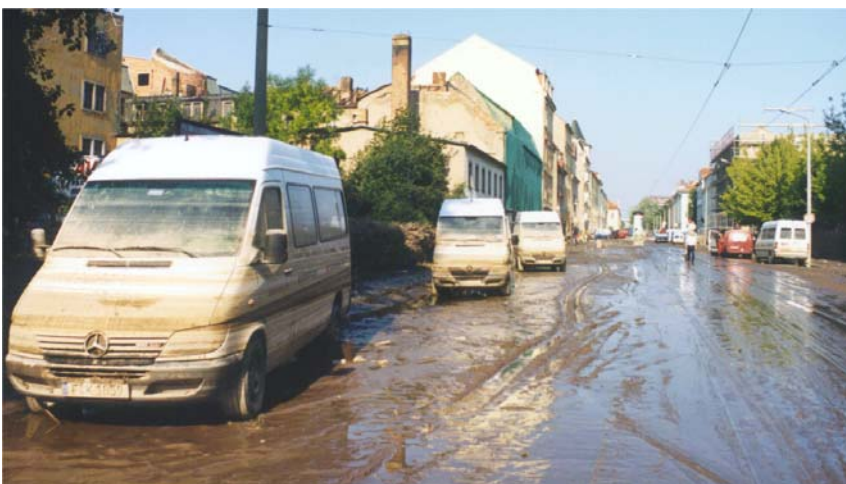
Centre of Dresden: This street remains virtually impassable, being filled with ~10cm of mud.

An even larger effort is required once flooding has passed, although without the time pressure. Disposal of sand bags and damaged property creates a problem in addition to the clean-up of property and streets required. In many areas, the deposition of tens of centimetres of mud, sometimes polluted, has made streets impassable. This mud must be cleared away, and drains unblocked, before the water remaining in many basements can be pumped away and damage can be repaired. Considerable loss due to business interruption is inevitable, especially in badly hit areas where the services required for a quick clean-up of buildings are over-stretched.

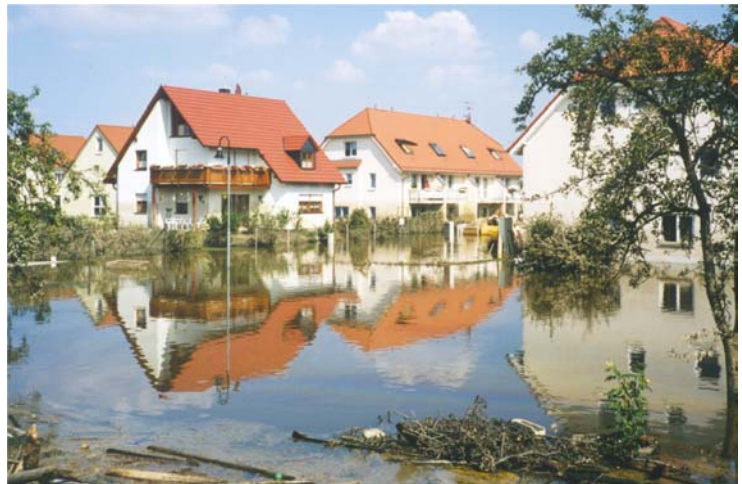
Flooded houses on the Elbe flood plain north of Dresden

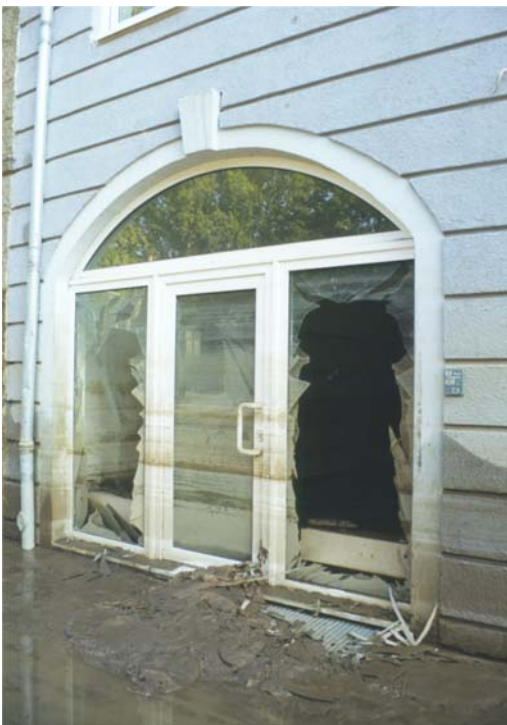
Collapse of glass-fronted office. The water level in this street reached ~1m above ground level.

Other than in areas directly adjacent to the river, where velocity of the water has been able to cause the collapse of some buildings, there is little evidence of structural failure. Minor damage may also occur where debris (e.g. trees and cars) are carried by flowing water. One major cause of direct structural damage is the presence of large panes of glass at ground level, notably in glass-fronted commercial properties at street level. Some collapses of weak retaining walls (e.g. garden walls) have also occurred where a wall has been sufficiently impermeable to allow water to build up on one side only.

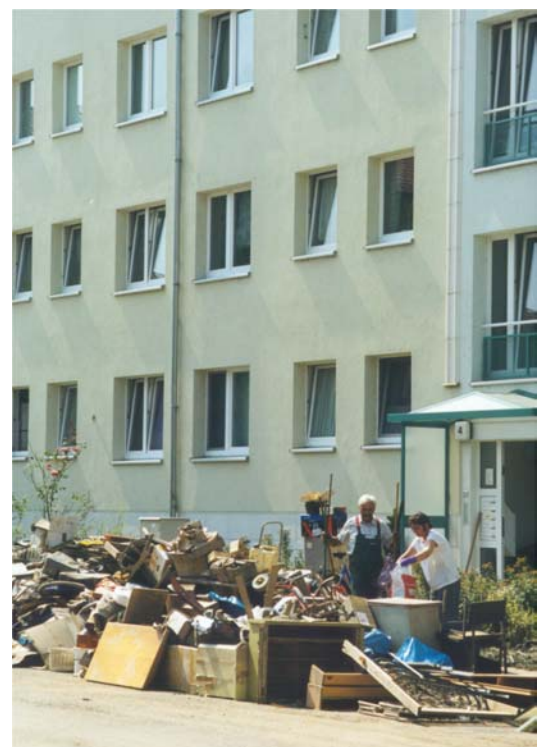
Contents damage in an apartment block in Dresden

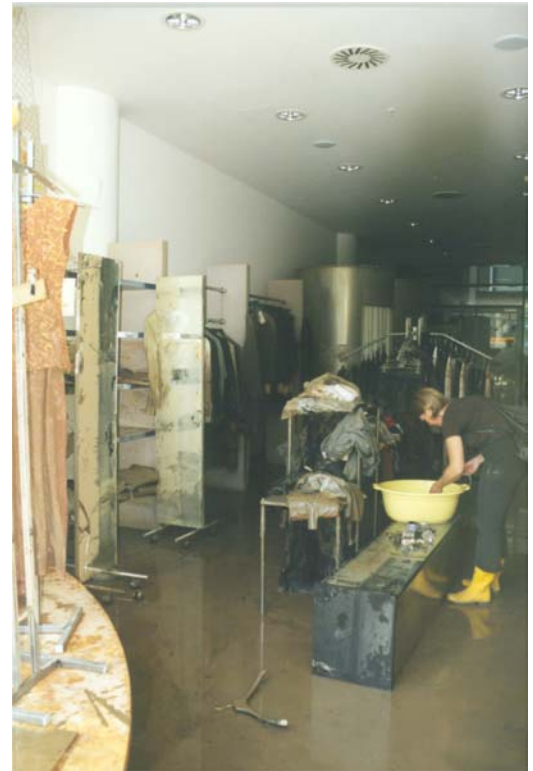
Contents damage to clothing store in Dresden

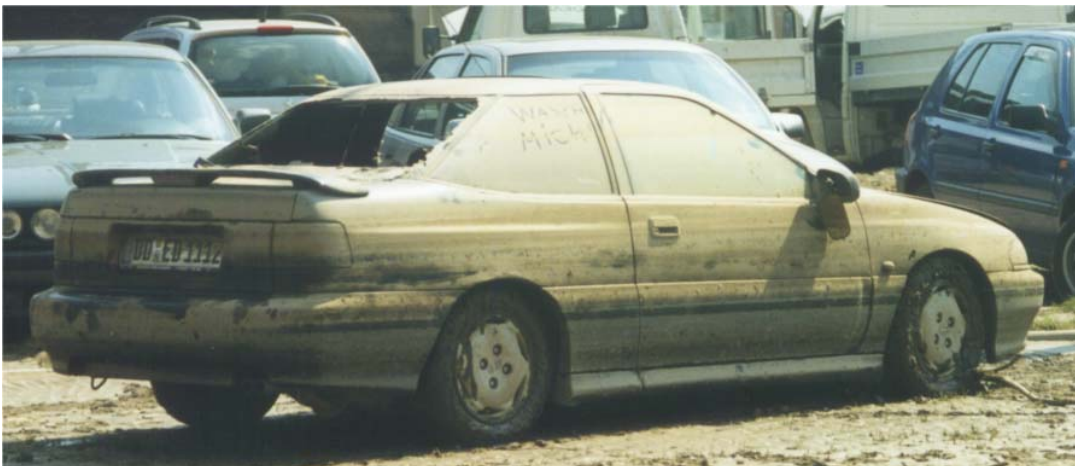
Motor vehicles, both privately owned and belonging to hire companies and in sales showrooms have suffered a great deal of damage. In areas where there is evidence of flowing water, cars have been transported tens if meters, resulting in further damage to nearby vehicles and property.

Damaged car, Germany
